Event Management Framework The Crescent Summer Series

Parramatta Park Trust

14 August 2018

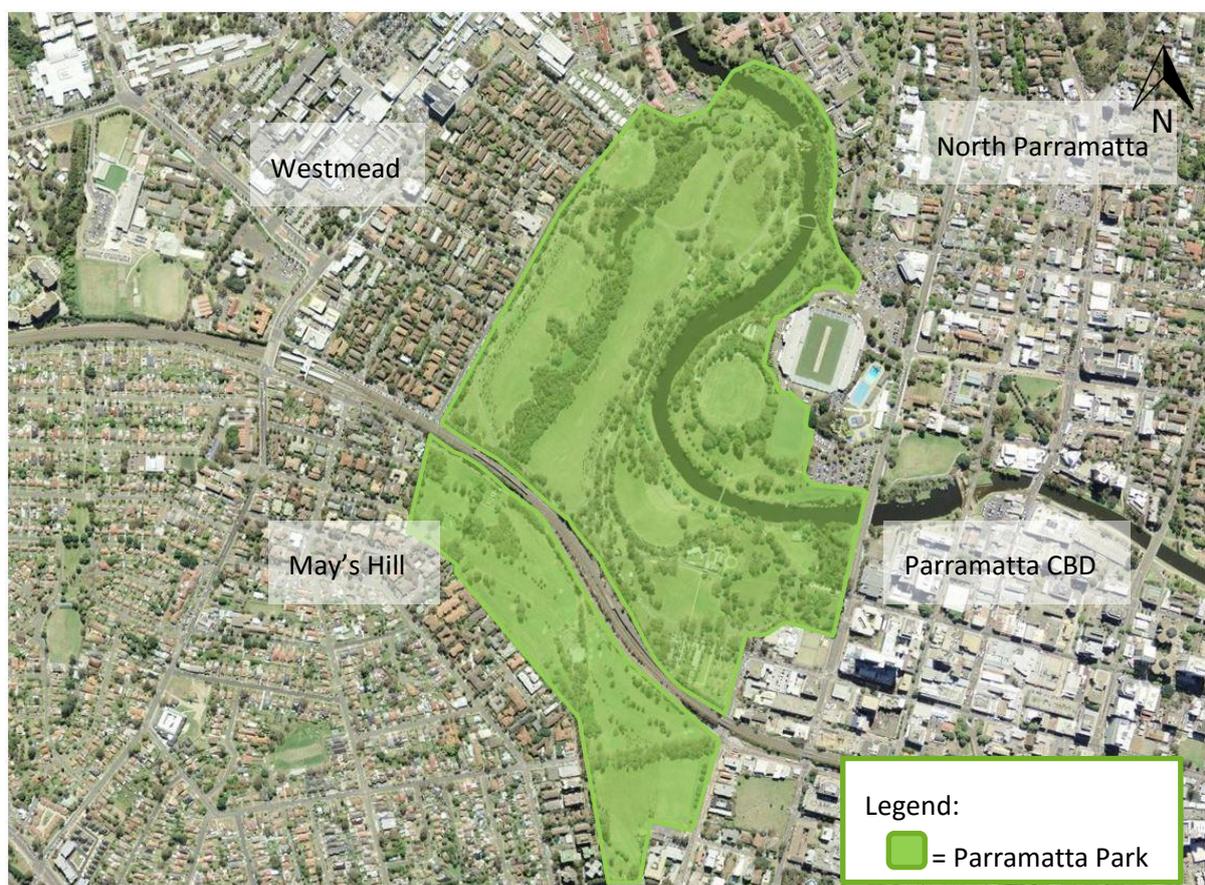
Figure 1- Map showing the footprint of Parramatta Park

Parramatta Park (Park) is located on the western edge of the Parramatta CBD and eastern edge of Westmead (see **Figure 1**). It is surrounded by one of the fastest growing residential and business areas in NSW. The Park has operated as a public park for 160 years and attracts more than 2 million visits each year.

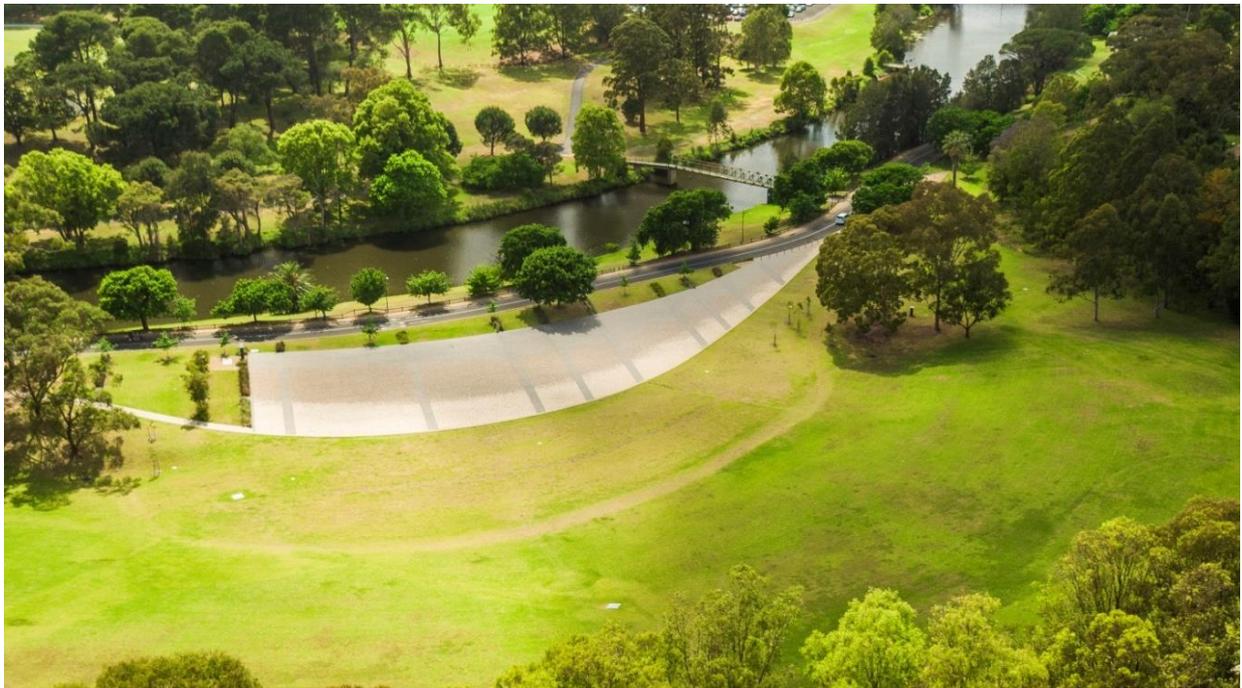
Figure 4 Image of the Crescent site

The Crescent is a natural amphitheatre located in the centre of the Park, below Old Government House (see **Figures 4**). It sits on 42,000m² of clear, unobstructed turf on a gentle slope alongside the Parramatta River. It is popular for large community and commercial events such as the Sydney Symphony Orchestra Concert, Australia Day and more. Staircases connect the amphitheatre to the top of the Crescent ridgeline.

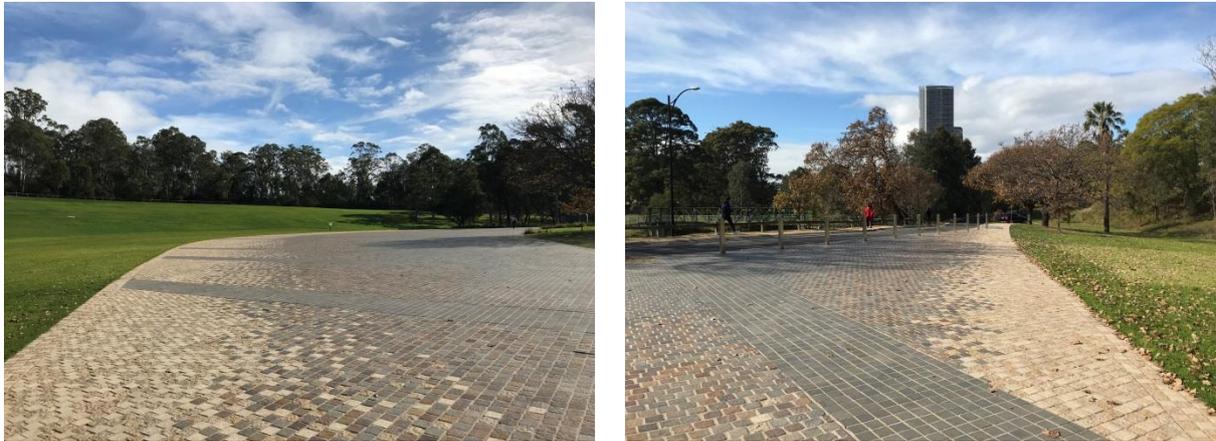
Figure 8: Images of Hardstand Area

The 2,000m² Crescent hardstand paved area (see **Figure 8**) located at the bottom of the Crescent amphitheatre along Byrnes Avenue has been designed to support the load of stage structures and other back of house ancillary infrastructure required for the staging of large events.

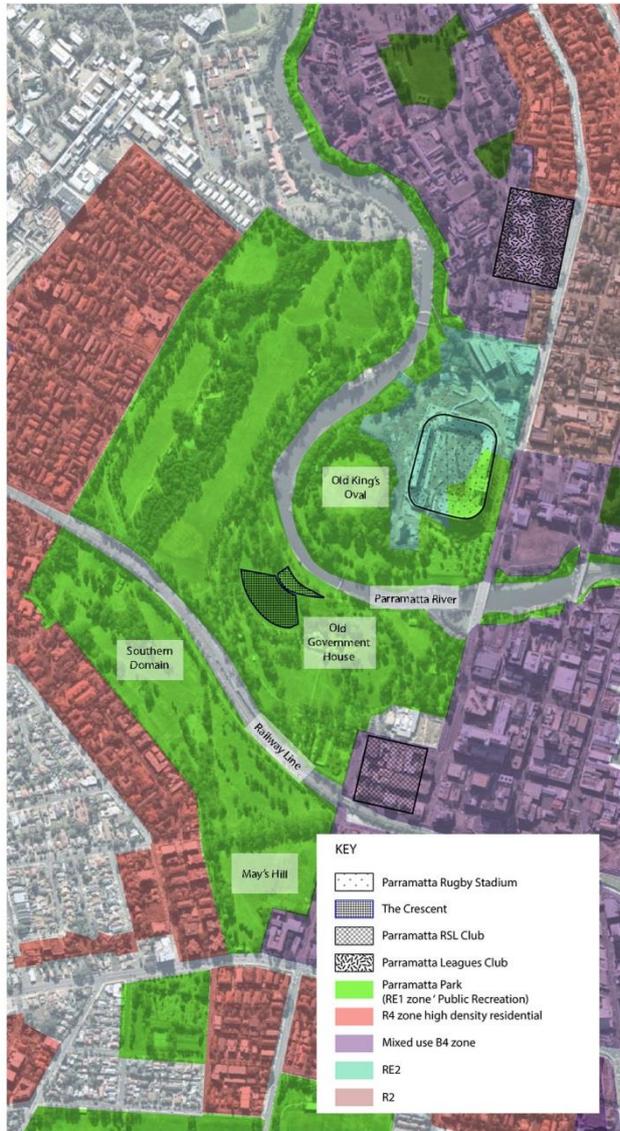
Figure 9 Zoning Plan of Park and Surrounds

The Park is bordered by an R4 High Density Residential zone to the west, and a B4 Mixed Use zone to the east (Parramatta CBD). Other event facilities near The Crescent include Parramatta Stadium, Parramatta RSL Club and Parramatta Leagues Club. This indicates that The Crescent is not isolated in a quiet residential area; and that it interfaces other event and user facilities (see **Figure 9**).

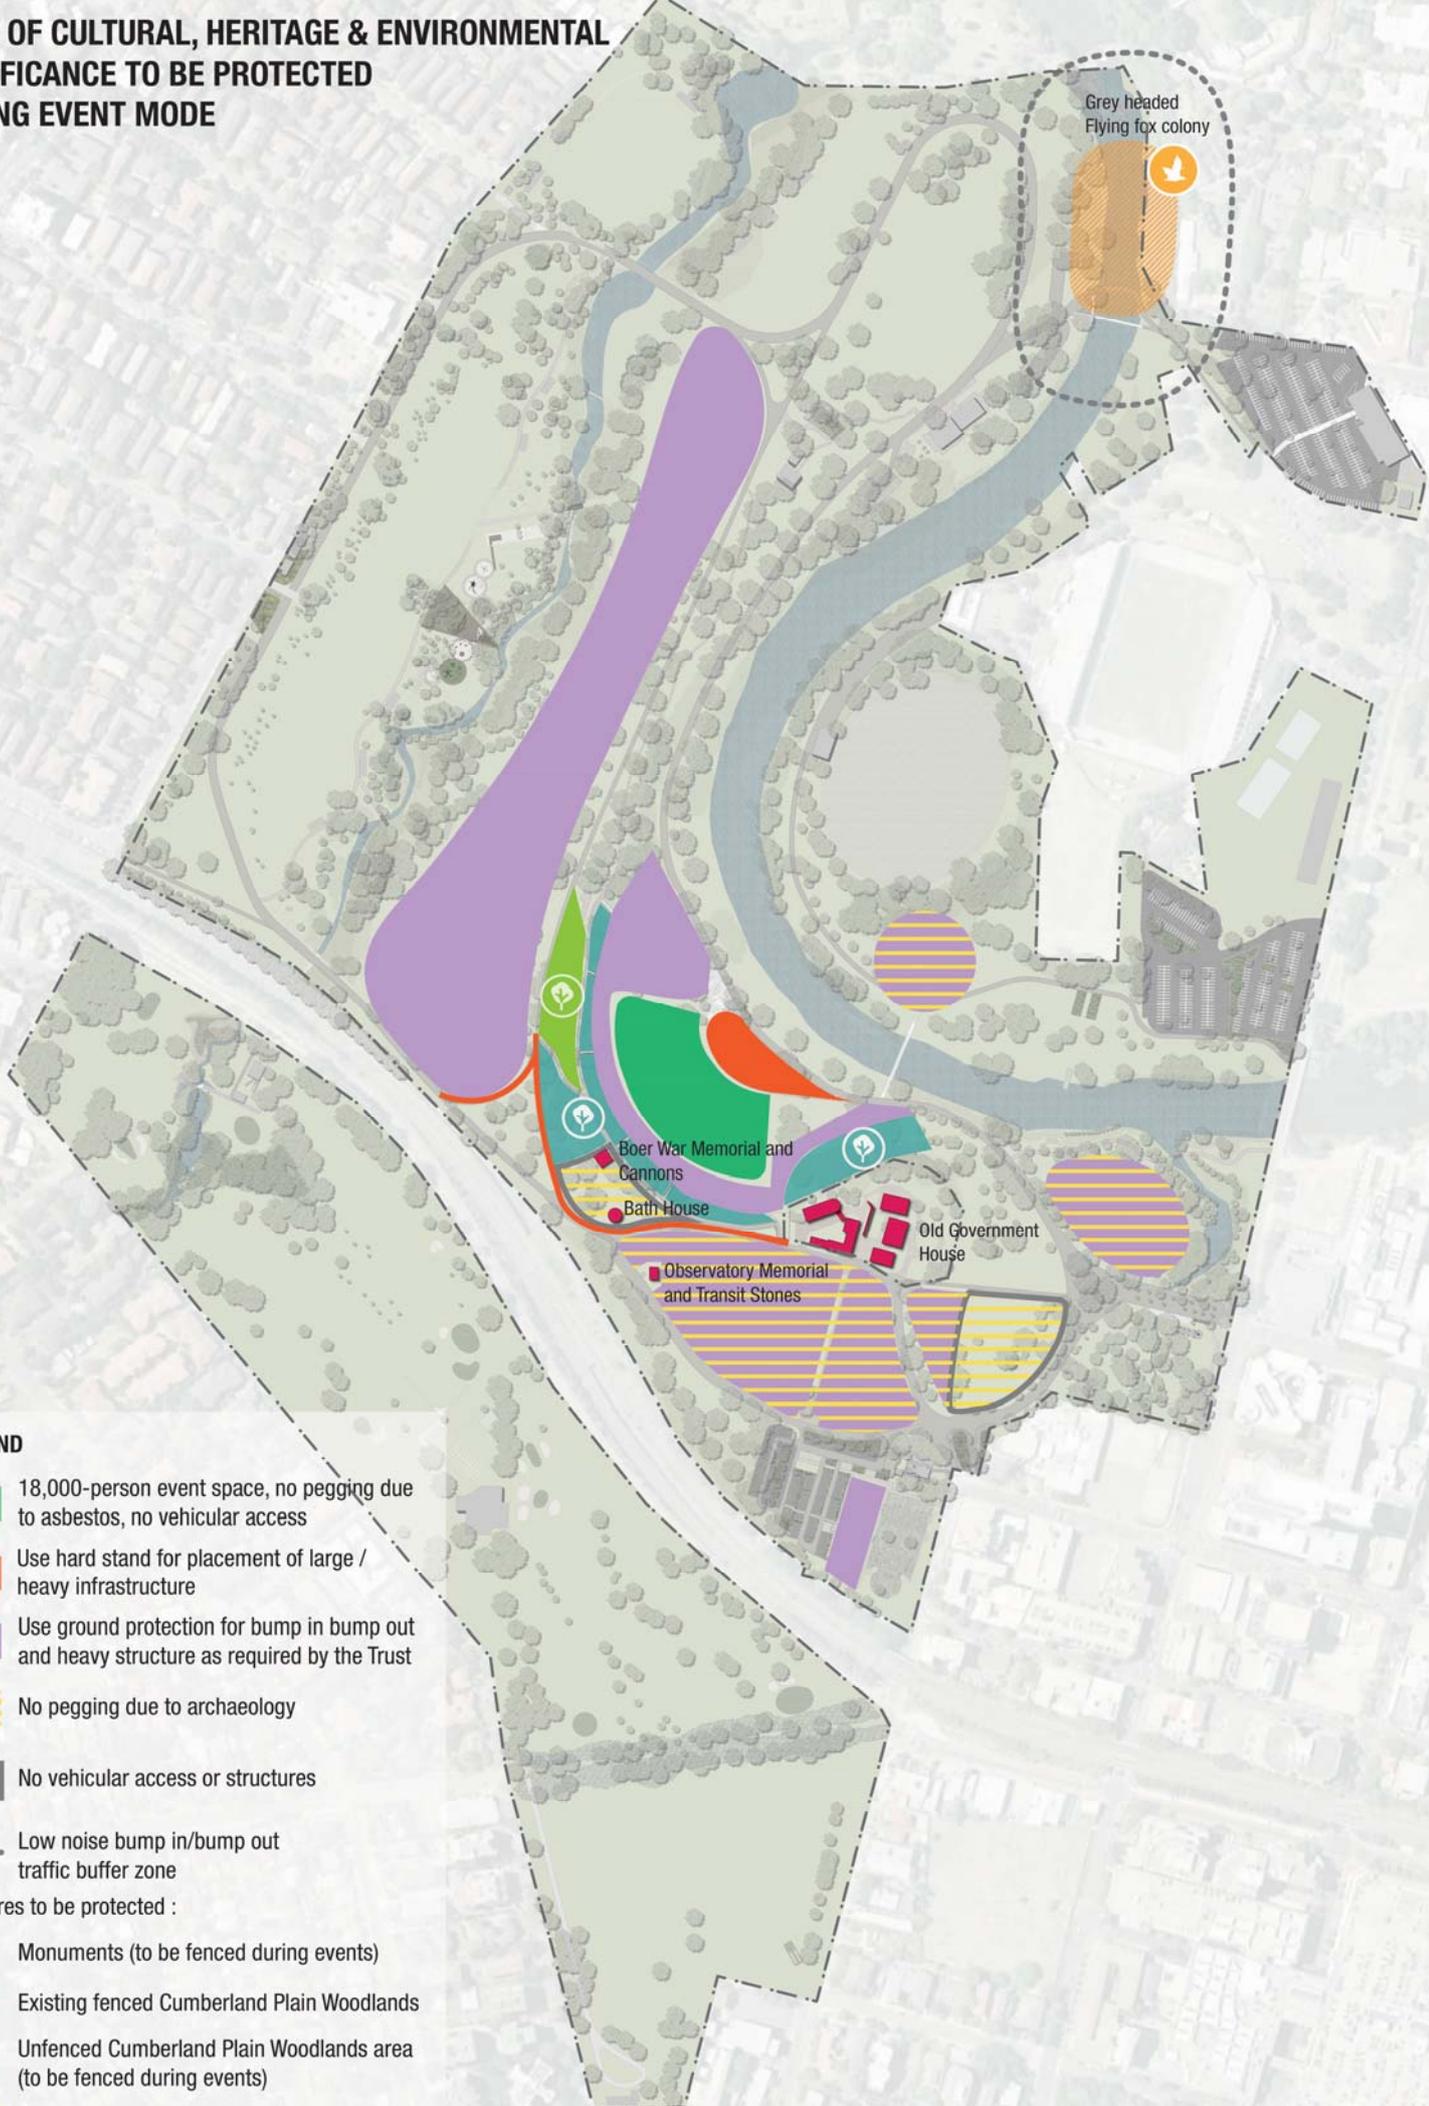
GENERAL GROUND PROTECTION ARRANGEMENT

- 18,000-person event space, no pegging due to asbestos, no vehicular access
 - Use hard stand for placement of large / heavy infrastructure
 - Use ground protection for bump in bump out and heavy structure as required by the Trust
 - No pegging due to archaeology
 - No vehicular access or structures
 - Low noise bump in/bump out traffic buffer zone
- Features to be protected :
- Monuments (to be fenced during events)
 - Existing fenced Cumberland Plain Woodlands
 - Unfenced Cumberland Plain Woodlands area (to be fenced during events)
 - Grey-headed Flying fox colony

The Hirer is to demonstrate compliance with the ‘General Ground Protection Arrangement’ map available in **Appendix A** and is to plan for the protection of surfaces from damage and compaction by preparing and submitting for approval a Ground Protection Plan.

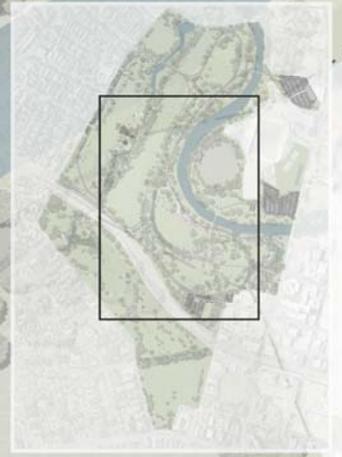
THE CRESCENT SUMMER SERIES - TYPE A EVENT AREA PLAN

- Temporary Stage and storage area
- Event Capacity (Seating or standing)
- Event secondary spaces includes:
 - ① Access
 - ② Toilets, food & beverage, small event specific
 - ③ Emergency vehicles
- Cumberland Plain Woodlands
- Emergency evacuation buffer & Gentle breakout space
- Permanent Fence
- Temporary Fence

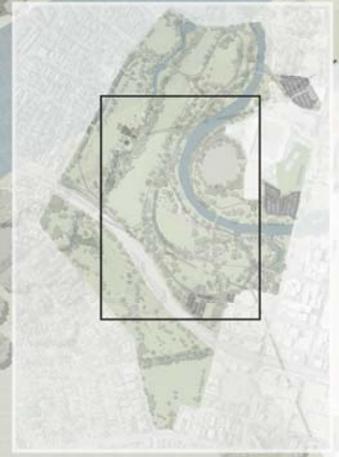
THE CRESCENT SUMMER SERIES - TYPE B EVENT AREA PLAN

- Temporary stage and storage area
- Event Capacity (Seating or standing)
- Event secondary spaces includes:
 - ① Ticketing booths (1-6 depend on event)
 - ② Access
 - ③ Toilets, foodtrucks and other small event specific infrastructure
 - ④ Performance preparation Area
- Cumberland Plain Woodlands
- Emergency evacuation buffer & Gentle breakout space
- Permanent Fence
- Temporary Fence

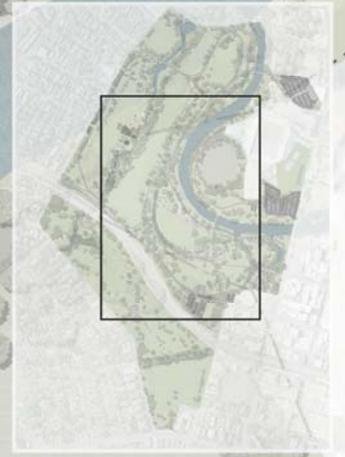
THE CRESCENT SUMMER SERIES - TYPE C EVENT AREA PLAN

- Stage Installation Area
- Event Capacity (Seating or standing)
- Event secondary spaces includes:
 - ① Ticketing booths (1-6 depend on event)
 - ② Access
 - ③ Toilets, foodtrucks and other small event specific infrastructure
 - ④ Performance preparation Area
 - ⑤ Stages in Cattle Paddock for multi stage event
- Cumberland Plain Woodlands
- Emergency evacuation buffer & Gentle breakout space
- Permanent Fence
- Temporary Fence

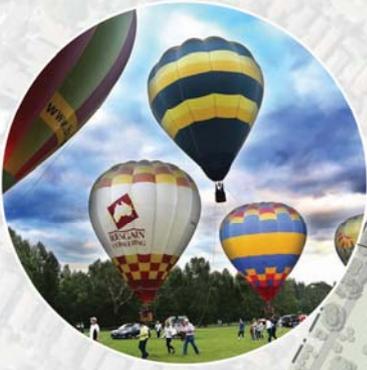
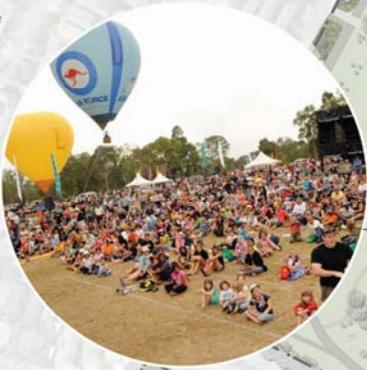
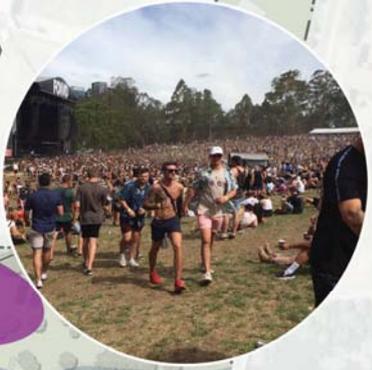
THE CRESCENT SUMMER SERIES - TYPE D EVENT

- Stage Installation Area
- Event Capacity (Seating or standing)
- Event secondary spaces includes:
 - ① Access
 - ② Amenities, food & beverage
 - ③ Emergency vehicles
 - ④ Stages
 - ⑤ Carnival rides
 - ⑥ Events
 - ⑦ Displays (antique cars & dog shows)
- Cumberland Plain Woodlands
- Emergency evacuation buffer & Gentle breakout space
- Gentle breakout space only
- Temporary Fence
- Permanent Fence
- ↓ Grey-headed Flying fox colony
- Fireworks Zone

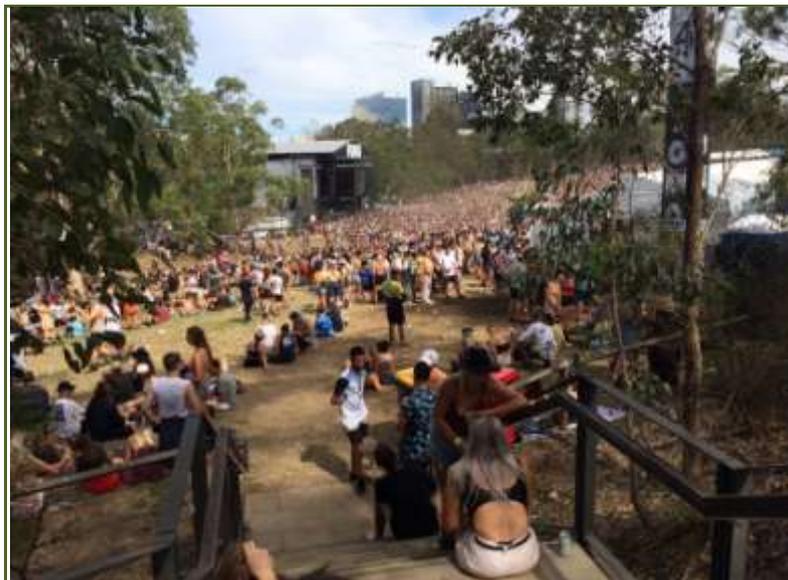
These *Type C* ticketed events may utilise The Crescent hardstand staging area and amphitheatre and require temporary fencing. Overflow event acts and stalls are located in the Cattle Paddock Precinct. Ancillary temporary event infrastructure (amenities, skip bins, food and beverage stalls) are located within The Crescent in areas of low archaeological potential. When required, these temporary structures may be located on existing hardstand areas including designated sections of Long Avenue and Governor Macquarie Carriage Drive. *Type C* events require ticketing booth zones on ‘Coronation Hill’.

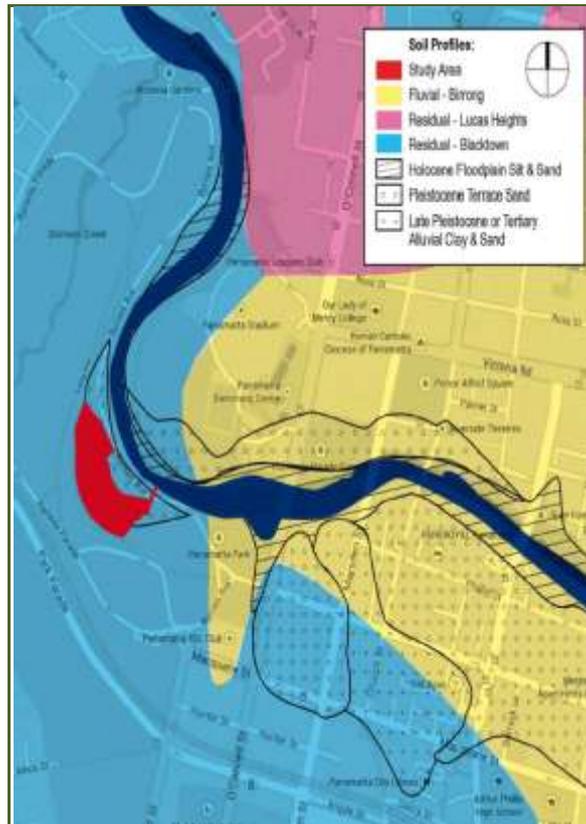
Figure 2.2: Soil relationships of the Blacktown Soil Landscape (Bannerman and Hazelton 1990: pp38)

The Crescent and Paddocks Precincts are located predominantly within the flood plain of Parramatta River excluding their western boundaries that intersect the foot-slopes of two separate ridges (Player 2016:1). The geological substrate is largely of the Wianamatta Group Ashfield Shale which is described ‘as dark grey to black claystone-siltstone and fine sandstone-siltstone laminite’ (Clark and Jones 1991). In broad terms, soils on The Crescent ridge and slopes comprise those of the Blacktown Soil Landscape, and alluvial deposits predominate subsurface within the interior of The Crescent as discussed in further detail in following sections.

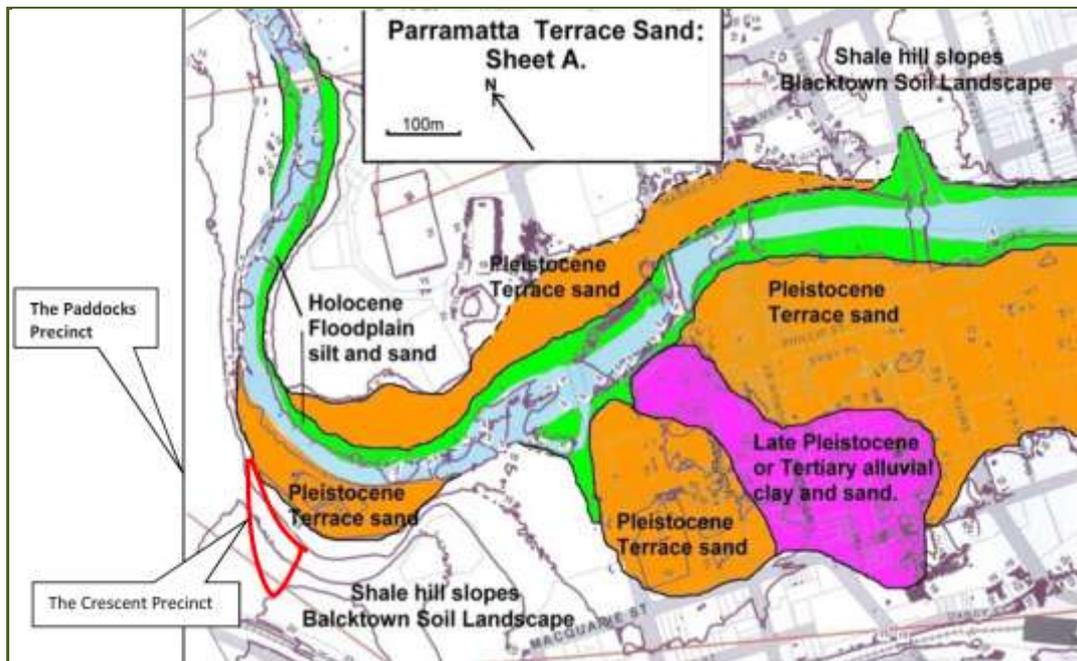
Figure 2.3: Indicative distribution of the different soil parent materials and landscapes along the Parramatta River (Comber Consultants 2016: Figure 7 after Mitchell 2011)

Thermoluminescence (TL) dates for the main body of sand (140 Macquarie Street - Comber Consultants 2010) show the top of the undisturbed sand (below the level of Aboriginal occupation discussed below) is between 50,000 to 58,000 years old. Deeper sand may relate to a period of higher sea level when the river channel was higher in the landscape, but may not be as old as c.120,000 BP as previously thought given the archaeology near the 'bottom' of the dated RTA-G1 sequence is dated to c.30,000 BP.

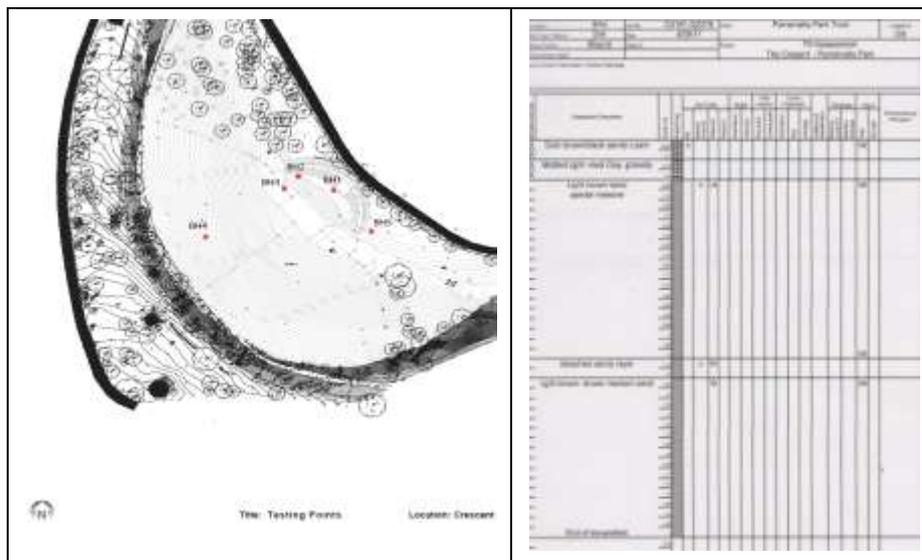
Figure 2.3: Geotechnical bore logs recorded in The Crescent in 2011 (Sydney Environmental and Soil Laboratory 2011)

BH4 was located about two-thirds up the slope of the stage area in the centre of The Crescent and recorded a far shallower occurrence of fill (about 20-25cm) over what are described as massive apedal light brown medium sands with a thin bleached sandy layer occurring at about 115cm, after which light brown medium sands continue down to a further depth of over 2.0m (end of bore-log excavation). The term apedal refers to the naturally occurring aggregation process of soil particles from that form peds and their structure where soils with specific characteristics are called pedal soils (such loams and clays) and soils which do not are called apedal (sands).

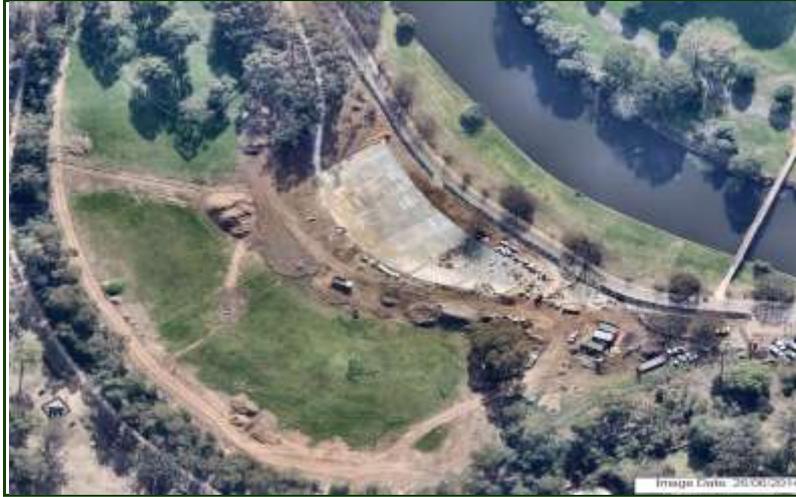
Figure 2.5: The Crescent SEMP (URS Australia Pty Ltd 2015: Figure 2)

The remaining portion of the containment area, as well as areas of The Crescent where ACM was identified, was capped with a geofabric membrane overlain by validated clean imported soil material. Surface soil from a dozen areas across the grassy slopes within The Crescent were analysed and found to be suitable for the use of the area (not covered by the stage) as public open space.

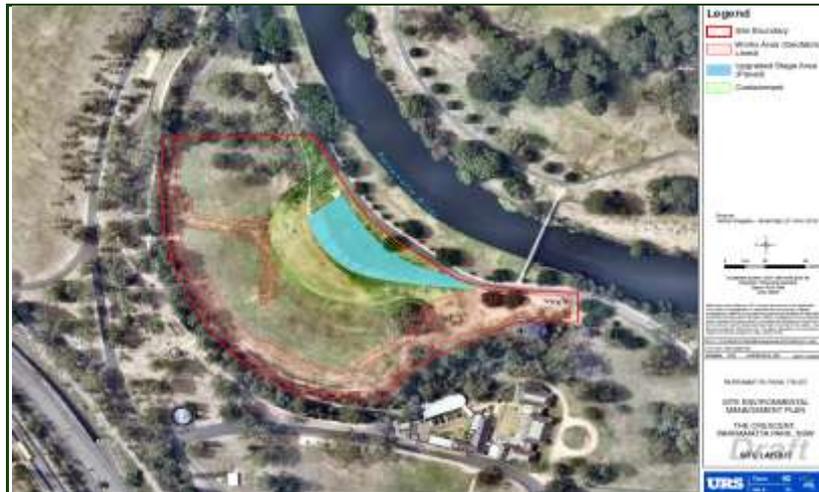
The SEMP (ibid:7) concluded the capping provided to the ACM containment area and elsewhere where ACM was encountered was not expected to be affected by routine use of the site by the general public and that the SEMP did not apply to those activities but would for any activity requiring disturbance of the subsurface SEMP. The 2011 works (stage area) included the removal of a toilet and associated sewer connections, excavation and removal of surplus soil so a stage area could be capped by a layer of material with no ACM, and placement of a visual barrier of white non-woven geofabric on the ACM before introduction of capping material. These works documented ACM fragments '*broadly across the area, not isolated to any particular location*' and reported ACM was mainly present in clay fill underlying s topsoil surface which '*appeared to be in the most part free of ACM*' (ibid:13). The staged area was established with reinforced (250mm) pavers and compacted road base and a geofabric membrane across unpaved area, and overlain with 250mm of imported soil material. The Crescent SEMP provides 'cautious' management recommendations that are in principle commensurate with those that should be applied to the archaeological management of the place (as abridged):

- Maintenance of capping layers in containment areas provided by paving, geofabric and top soil layers.
- Ensuring intrusive activities which might result in exposure to buried ACM are undertaken in appropriate manner.

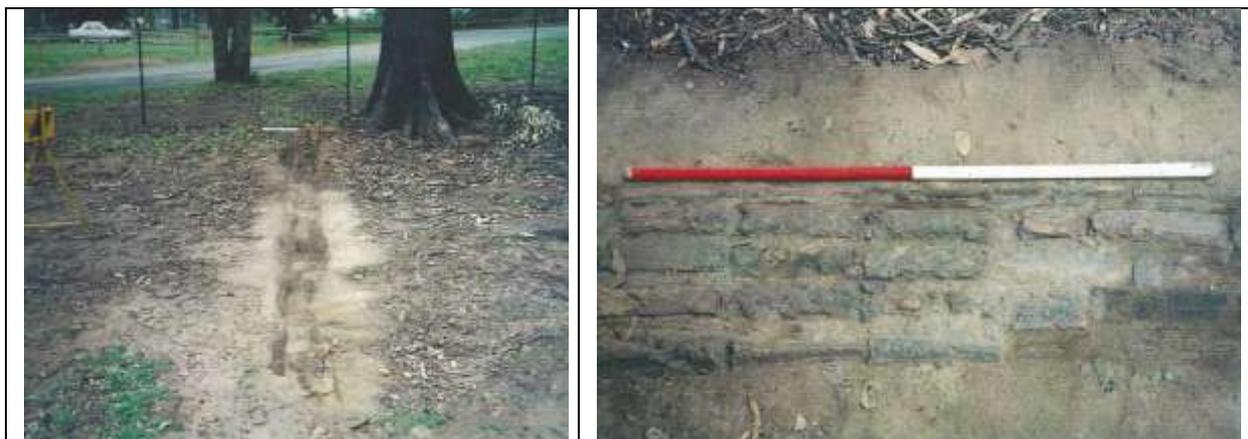
Figure 2.8: Sandstock brick drain section exposed by wind and rain near the Bathhouse in 1999 (Steele 1999). The exposed brickwork appeared to show evidence for having been exposed to the elements in the past (and prior to 1999) and no original (otherwise) soils were found to survive in this location. The clay shown either side of the drain brickwork is basal B-horizon Blacktown Clay that is missing entirely its A¹ and A² soil components and this occurs directly below the leaf-litter/grass layer. There was no soil with potential archaeological sensitivity and possibility to contain ‘relics’ or Aboriginal objects or archaeological deposits in this location

This can be exemplified by an exposure through the grass layer in 1999 of a couple of metres long section of a sandstock brick ‘barrel’ drain extending from a short distance the southeast side of the Bathhouse towards The Crescent. On comparative fabric analysis grounds for rudimentary dating, and by location and historical

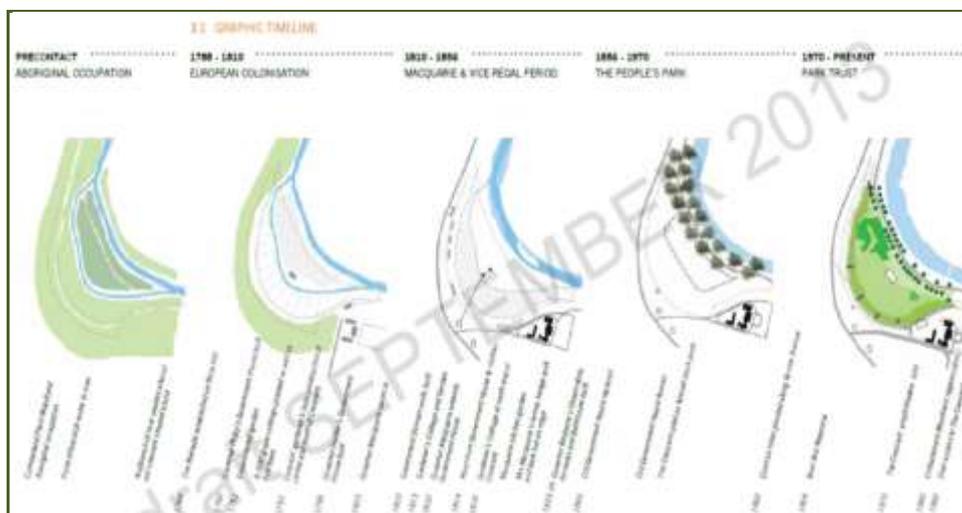
Figure 2.6: Visual timeline showing archaeological features within The Crescent landscape (GML 2018: Figure 3.3)

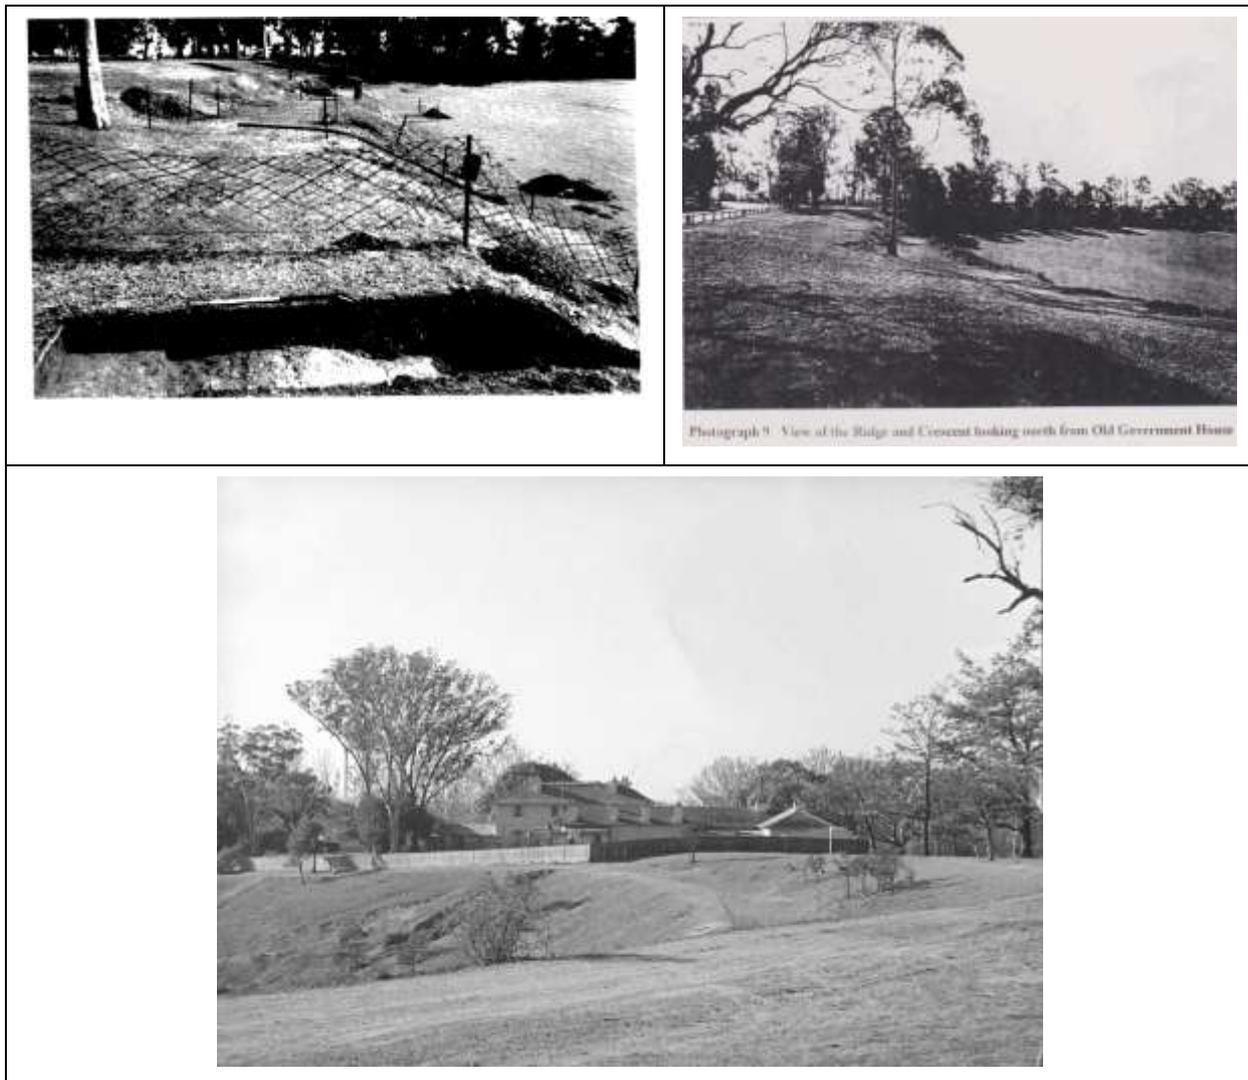
Figure 3.2: OGH rubbish dump excavation (left) in 1995 (Higginbotham 1999), the same location in 1996 (AMBS 1996) and undated view of same locality (bottom) from reverse view

1908 and that it was discarded at the same time that a rubbish dump was created that spilled over the Crescent. This refuse dump was test excavated in 1995 (Higginbotham 1999). The remainder of this archaeological deposit may remain where it was initially created.

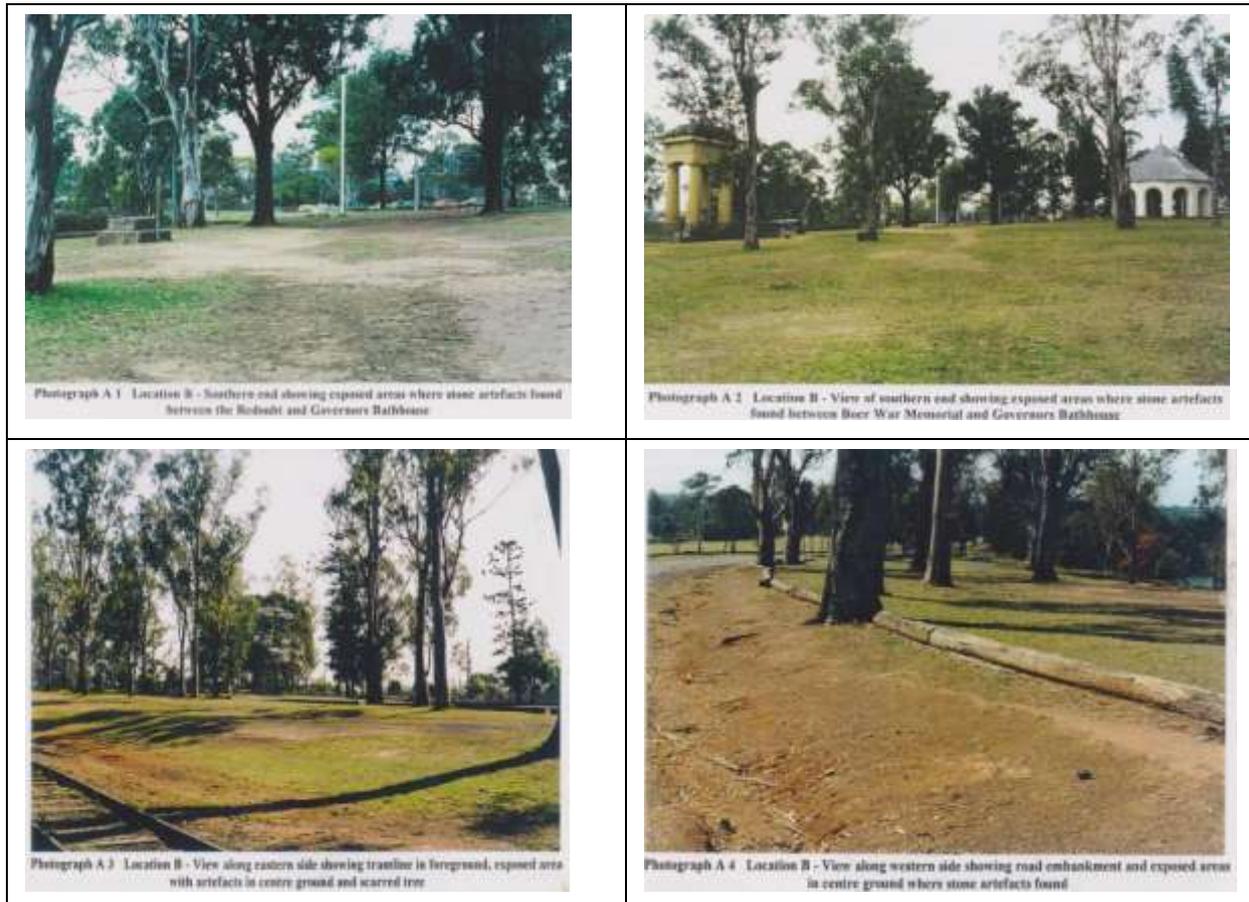
Figure 3.3: General views of the site recording of AHIMS #45-5-0864/AHIMS #45-5-0762 on The Crescent ridge (AMBS 1996: Appendix 2)

No. of artefacts: 43 (over 190m x 24m area)

Reason for artefact exposure: road and tramline construction exposing subsurface through to B horizon, erosion and exposure of ground over large areas through deflation and loss of grass cover through foot traffic

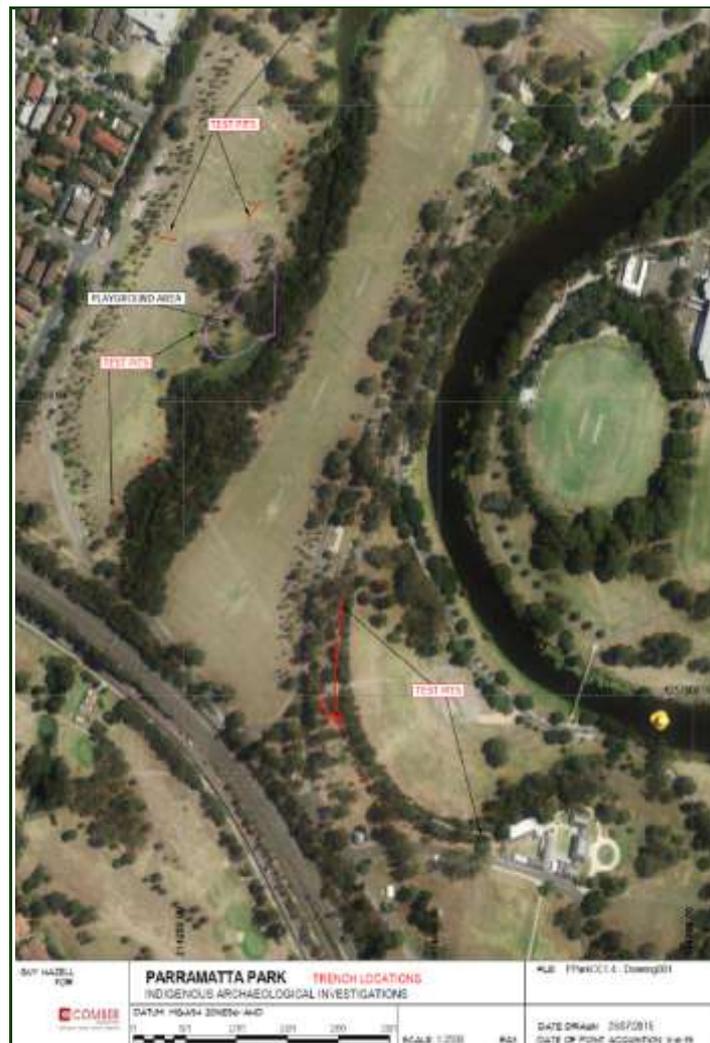
Figure 3.4: Aboriginal archaeological test excavation on The Crescent ridge and western side of Domain Creek (Comber Consultants 2015)

Approximately 63, 1x1m trenches were excavated on The Crescent ridge. Initially they were spaced at 5m but were subsequently excavated in one contiguous line. The soils are dealt with in greater detail in later sections of this report, but were found to be heavily disturbed, and to range from red sandy loam (Munsell 2.5yr range) which was introduced, light brown (5yr range) to dark brown (7.5yr to 10yr range). One intact soil profile was located beneath a historic shale surface. A small sample of Aboriginal objects (15) were recovered but with a slightly greater number of finds reported to occur to the north of the Boer War memorial.

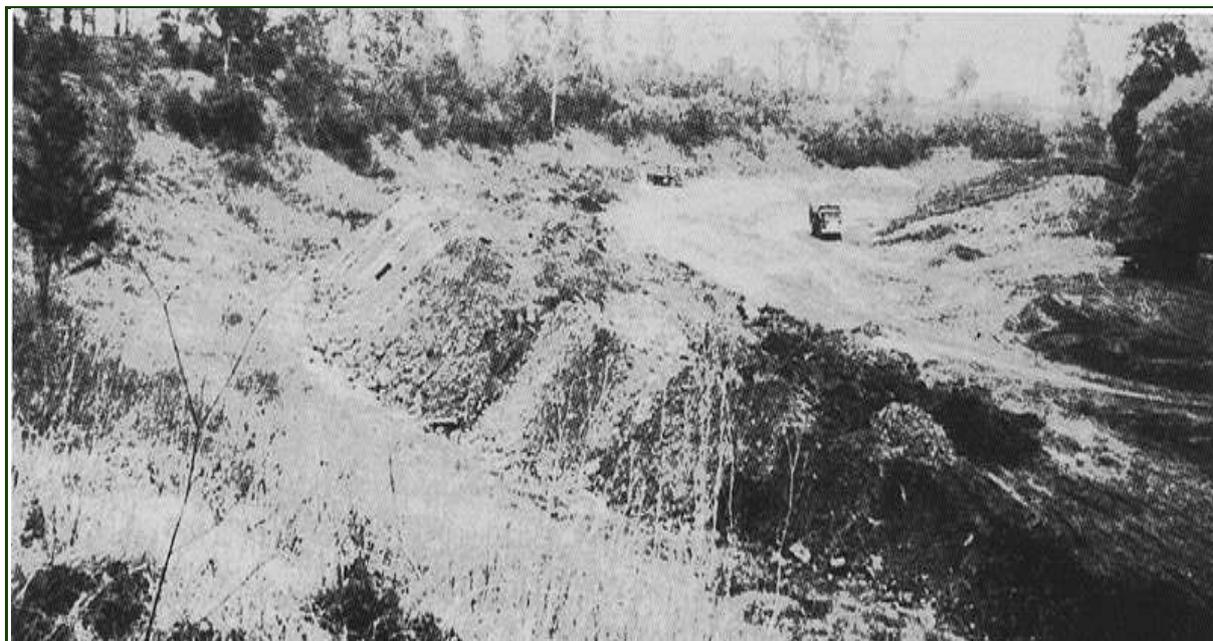
Figure 4.5: The Crescent being filled in 1961 (Source: Parramatta Argus, September 1977)

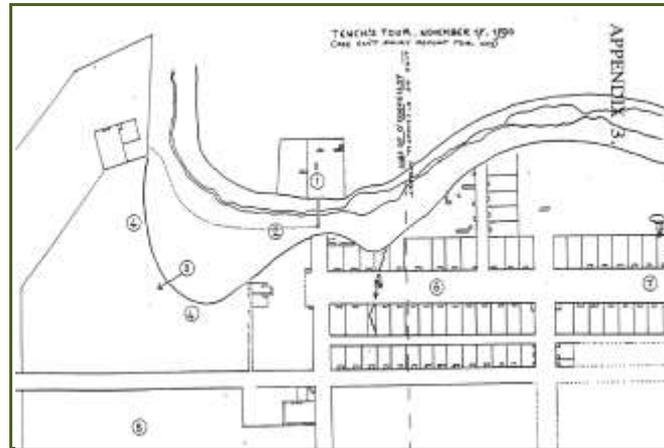
Figure 4.7 Map of Tench's November 1790 walking tour of the cultivated lands – compare the numbers with the map (Varman 1997:259)

1. Tench's survey began on the north side of the river where the barn and threshing floor etc are historically recorded, and then crossed the 'rivulet' to the south (OGH) side of the river.

2. He walked to the bottom of The Crescent and found a little patch of 'very bad' wheat growing.
3. From bottom of The Crescent he examined 'the large field on the ascent to the west ward' and found 25 acres in wheat.

5. The next patch from the wheat field was noted to be planted in maize.
6. From the 'Semicircular Hill', Tench crossed 'the old field, which is intended to form part of the main street of the projected town' (current George Street).

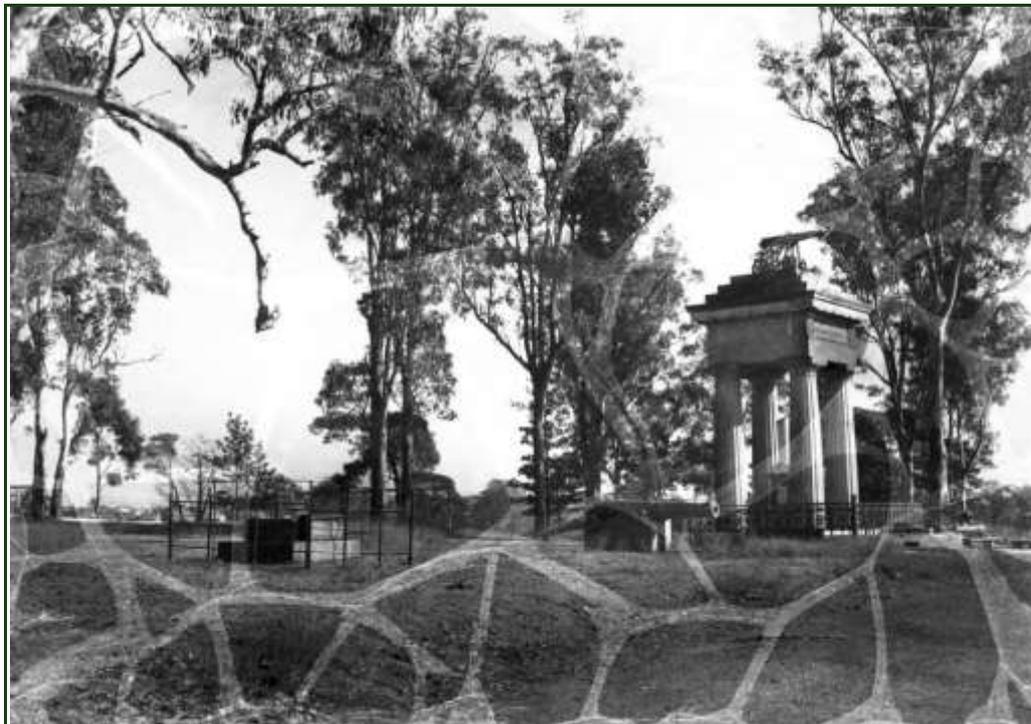
Figure 4.22: Undated image (post 1903) by Hurley of the Boar War monument on The Crescent ridge (Source: SLNSW PIC FH/7431 LOC Cold store PIC HURL 231/10). This image appear to show in the foreground where soil has been stripped down (to most likely basal clay) when comparing levels with the grass surfaces around the monuments

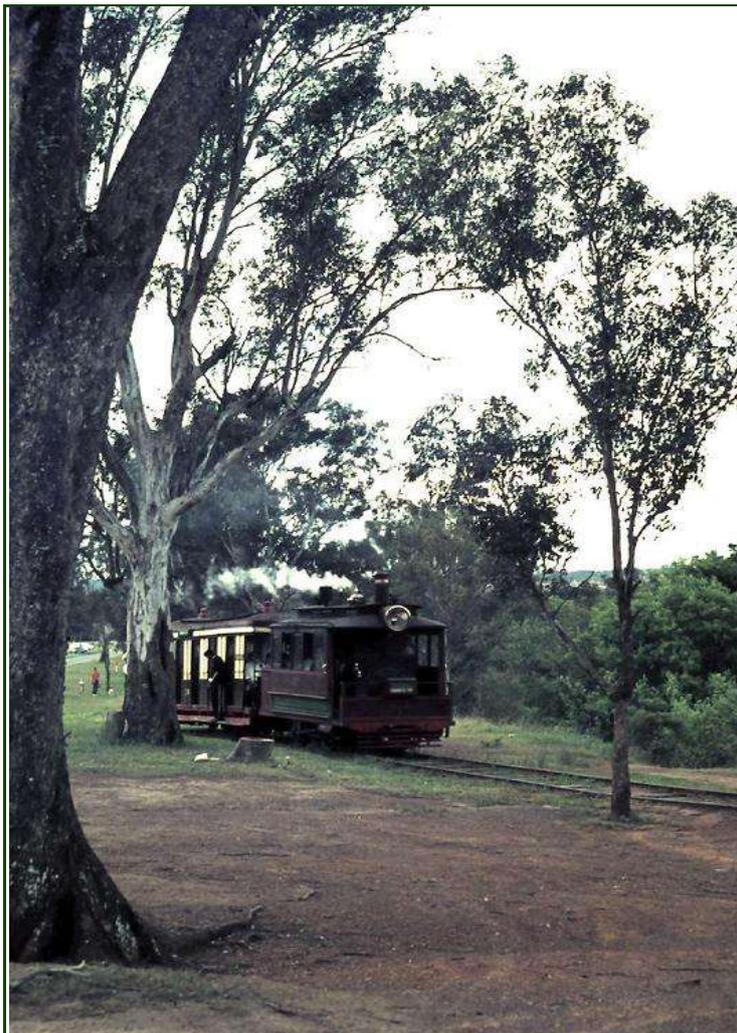
Figure 4.26: Note widespread absence of soil cover and exposed B-horizon clay (Source: Australian Transport Discussion Board - Online)

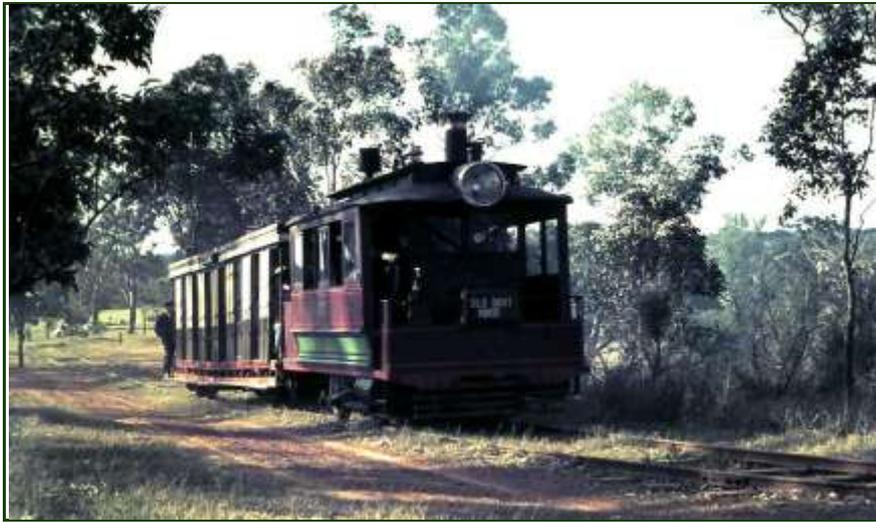
Figure 4.27: Note the construction of the tracks and continued use of the ram for approximately 38 years has removed soil cover and exposed basal clay (Source: Australian Transport Discussion Board - Online)

One of the historic impacts that we can reconstruct and estimate the archaeological impact of to some extent is for the use of The Crescent ridge for about thirty years from 1956 by the Steam Tramway and Railway Preservation Society (Varman 1997:210). The Society constructed a 570m long track with rails and ballast that commenced from a tram and equipment storage and maintenance shed formerly located adjacent to the Dairy Precinct (the shed burnt down in 1993) and extended to the Bathhouse. A clip of the Parramatta Park steam tram in operation (1980s) is on YouTube (https://www.youtube.com/watch?v=_zIRd5nnFul).

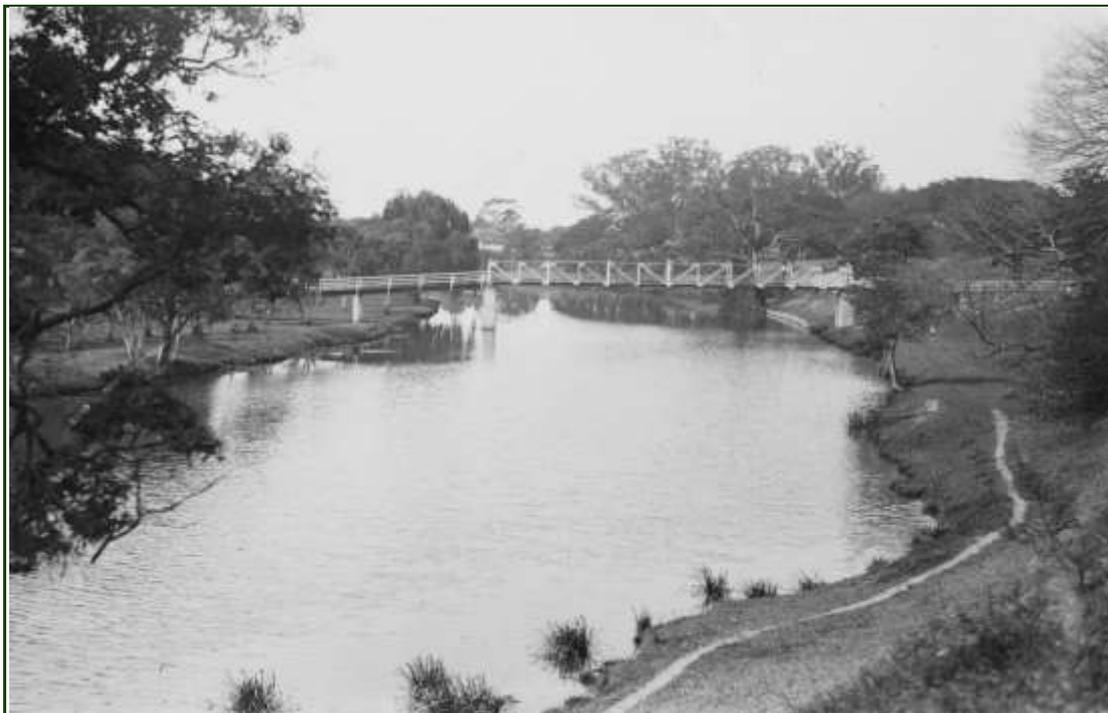
Figure 4.30: The river bank at Noller Bridge in c.1930 (Source: NLA PIC/15611/14613 LOC Cold store PIC/15611). Note that the section of stone wall evident on the southern side of the bridge has not extended to include the banks to the north and in front of The Crescent

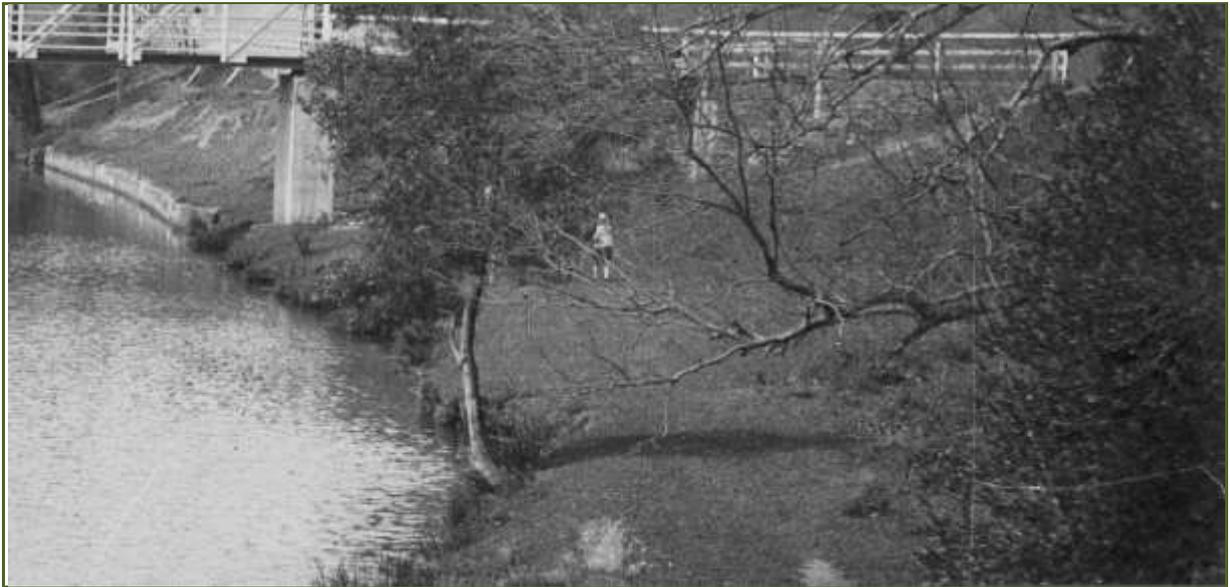
Figure 4.31: Enlarged image of section of stone wall on the southern side of the bridge and unformed banks to the north
