Event Management Framework The Crescent Summer Series

Parramatta Park Trust

14 August 2018

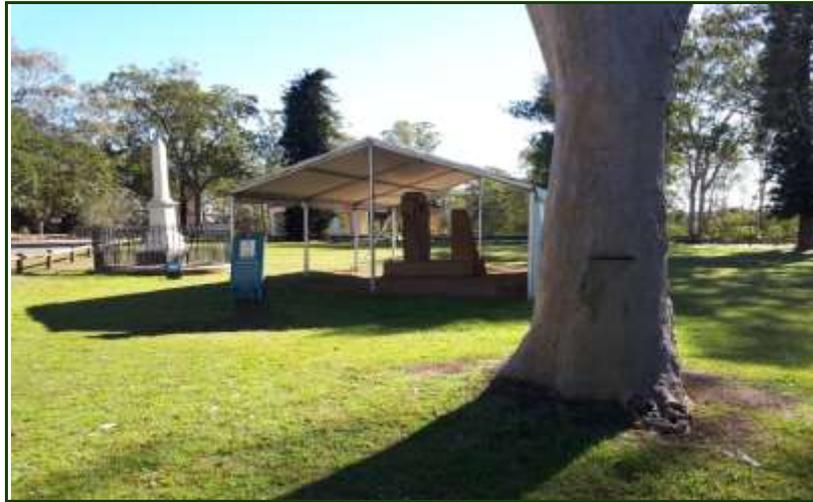
Figure 4.35: Existing condition of the Observatory site

Two separate excavations at the Observatory site (Archaeology & Heritage Pty Ltd 2011 and Casey & Lowe Pty Ltd 2014), located on the higher ground to the west of OGH, have shown the upper A-unit components of the soils in this locality are shallow and in places entirely missing.

The likely deflation of soils can also be inferred by looking at the ground levels at the base of the stone work illustrated in the second image. Although possible, it is unlikely that the difference in the ground level is entirely the result of deposit ‘slumping’ because stiff and compact Blacktown clay is located just below the grassed surface.

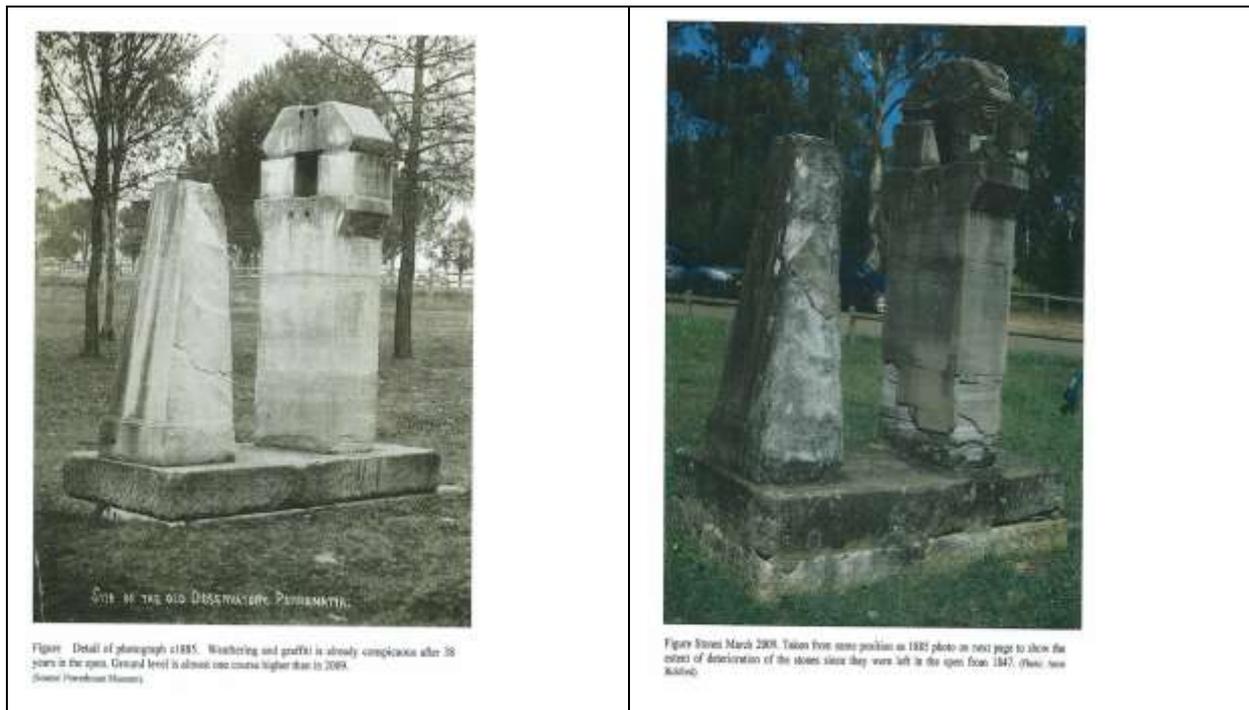
Figure 4.36: Comparison of ground level apparent at the base of the Observatory transit stones in c.1885 (left) and 2009 to the right (Archaeology & Heritage 2011:43-44)

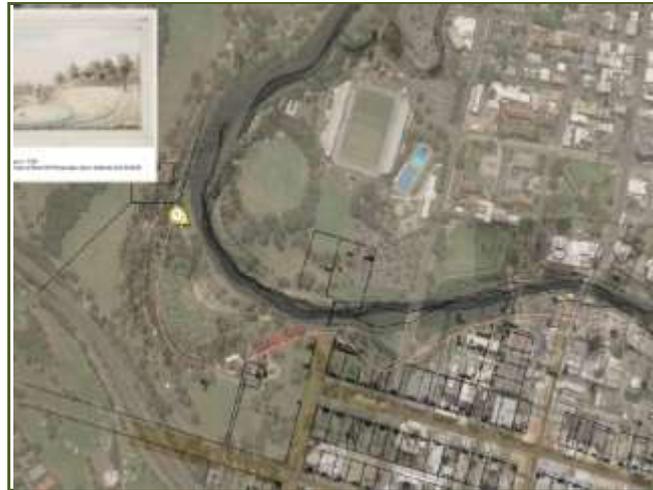
Figure 4.37: Overlay of the c.1792 and 1804 plans over 2016 aerial. The position of the river's 1792 embankment is shown as a red line (GML Pty Ltd 2016: Figure 4.2)

GML (2016:62-63) report there is little evidence to indicate that the land on the ‘Pavilion Flats’ area has been substantially land-formed other than the possibility of reclamation along the northern boundary. GPR survey appears to have identified the remains of historical structures associated with mapped historical structures and others that are not mapped. Because the geomorphology of the river bank deposits and their relationship to suspected and potential archaeological features and deposits in this area is current not well understood, the use of ground-penetrating anchoring spikes/pegs is recommended to be avoided. The EMP maps those areas in the Park where no ground disturbance through pegging is to be permitted during future CSS events.

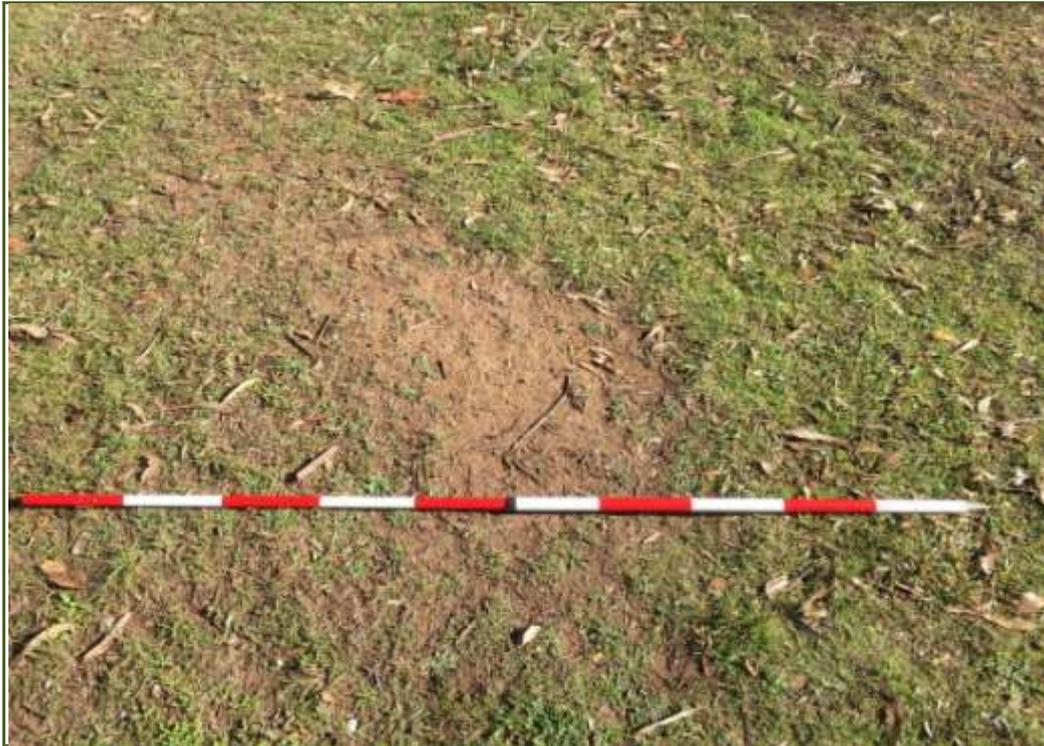
Figure 6.17: Typical ground conditions on the ridgeline: exposed reworked subsoils

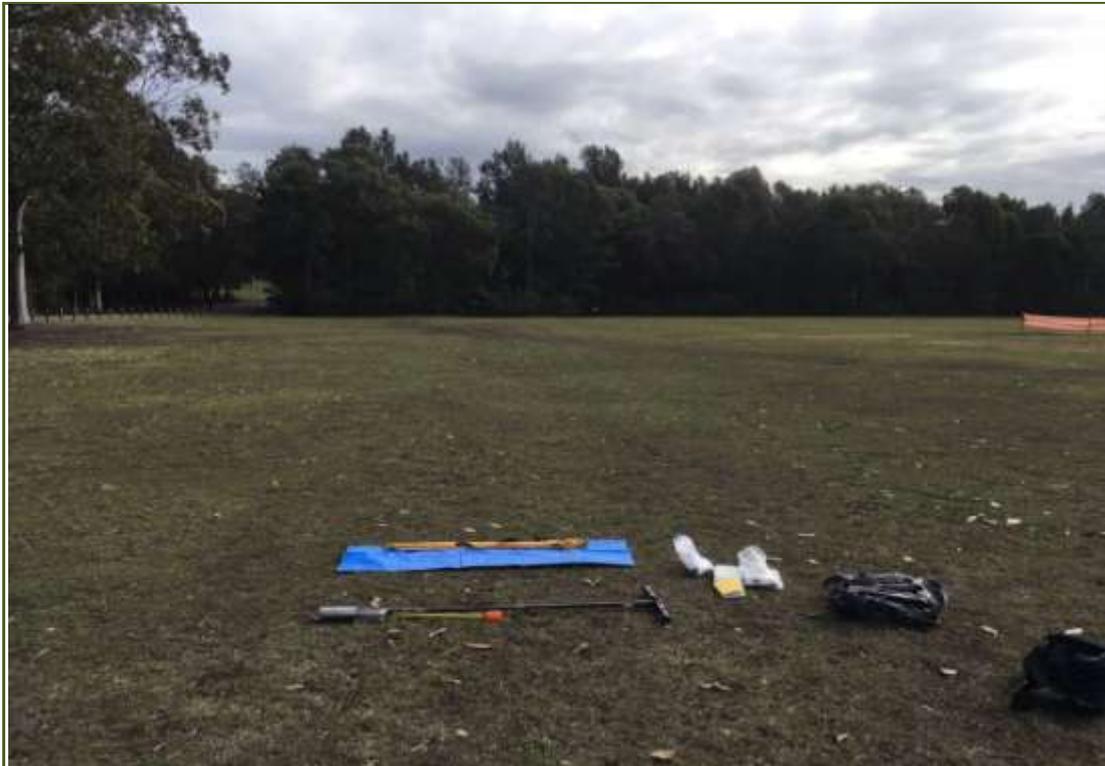
Figure 6.27: Deposits from PPAP17: 0m on the scale is the uppermost deposit

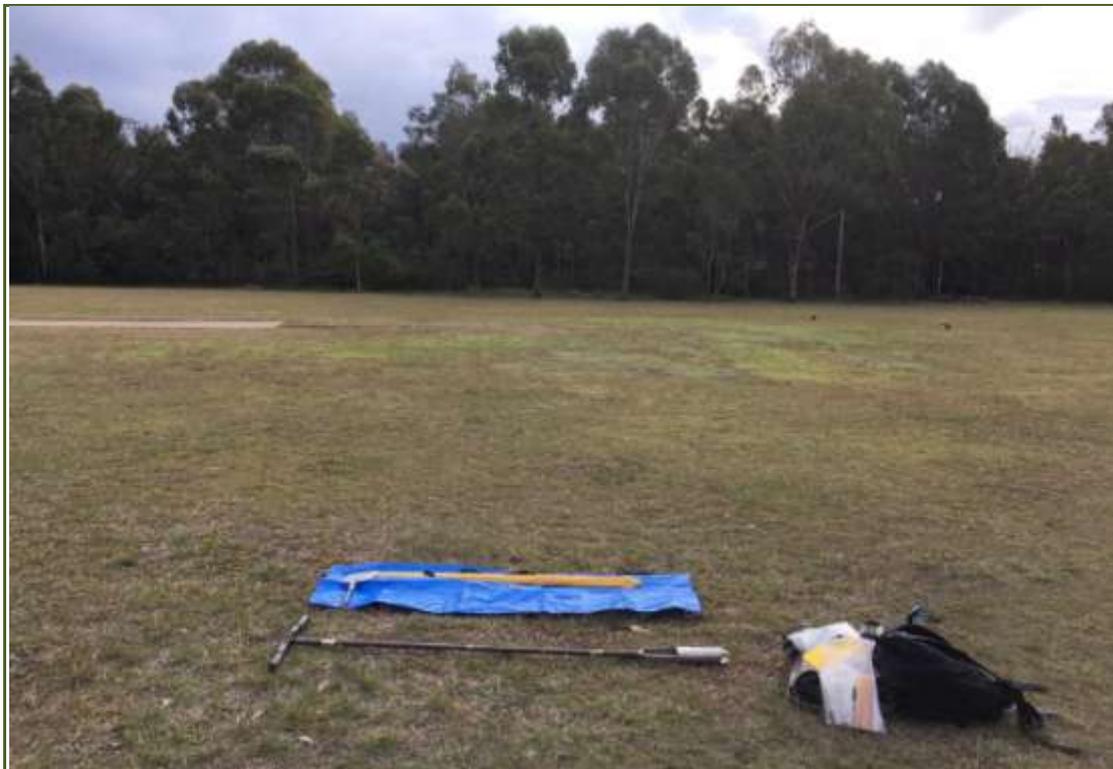
Figure 6.33: Deposits recovered from PPAP20: the uppermost layer is at 0m.

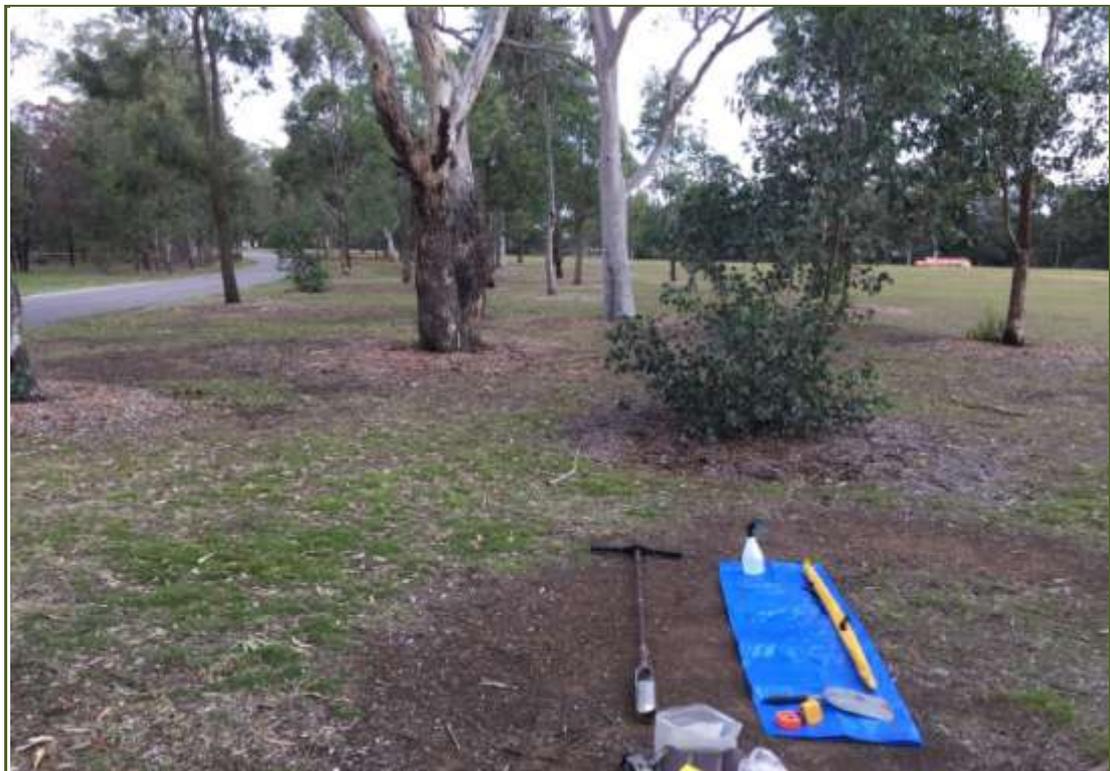
Figure 6.35: Deposits recovered from PPAP21: the uppermost layer is at 0m

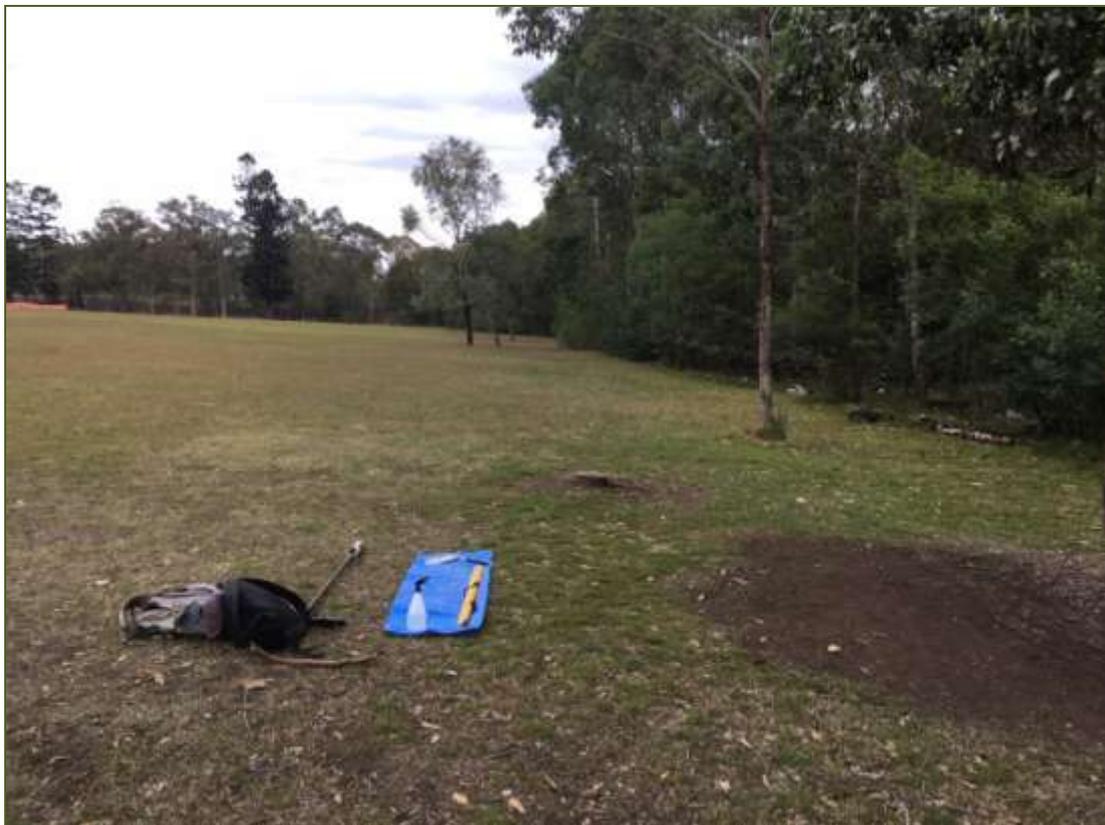
Figure 6.37: Deposits recovered from PPAP22: the uppermost layer is at 0m.
